**Snowmass Mountain Condominiums Construction Update
Weeks 18-19 August 15-29, 2011**

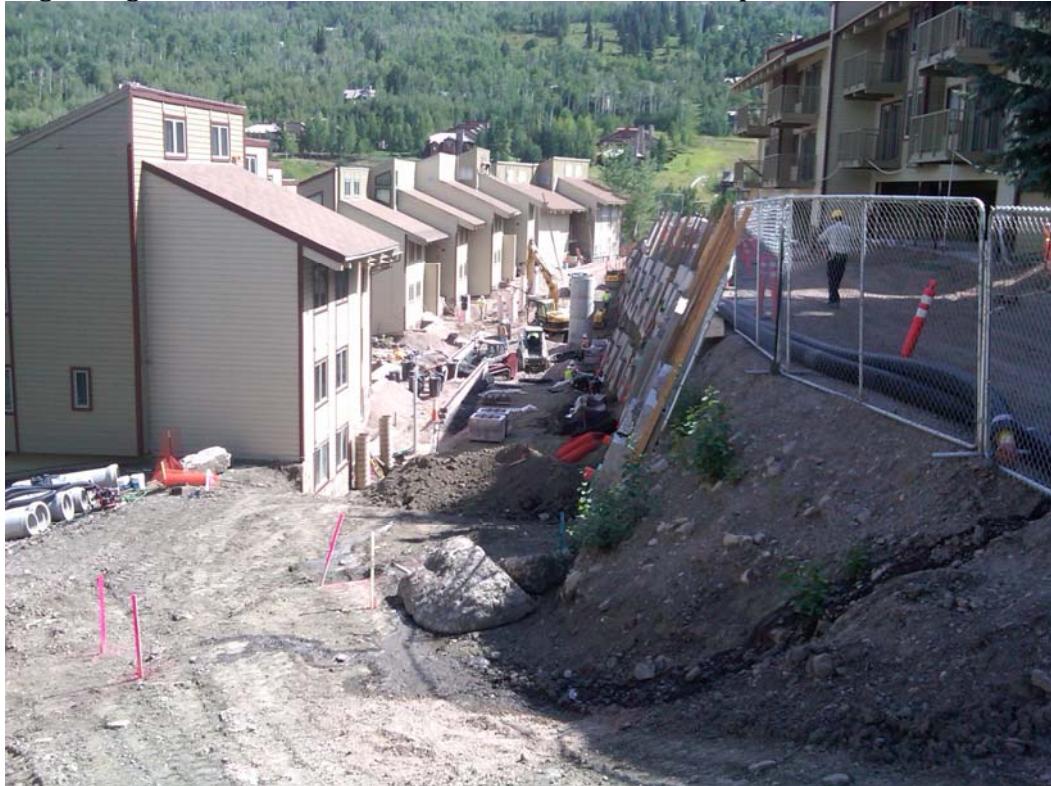
The next two pictures this week show some of this activity. The first one shows the view from the driveway area next to Building A looking down into the excavated area. In the center of the photo, the small line in both shadow and sunlight is the beginning of the MSE wall in this section. The second picture shows the same

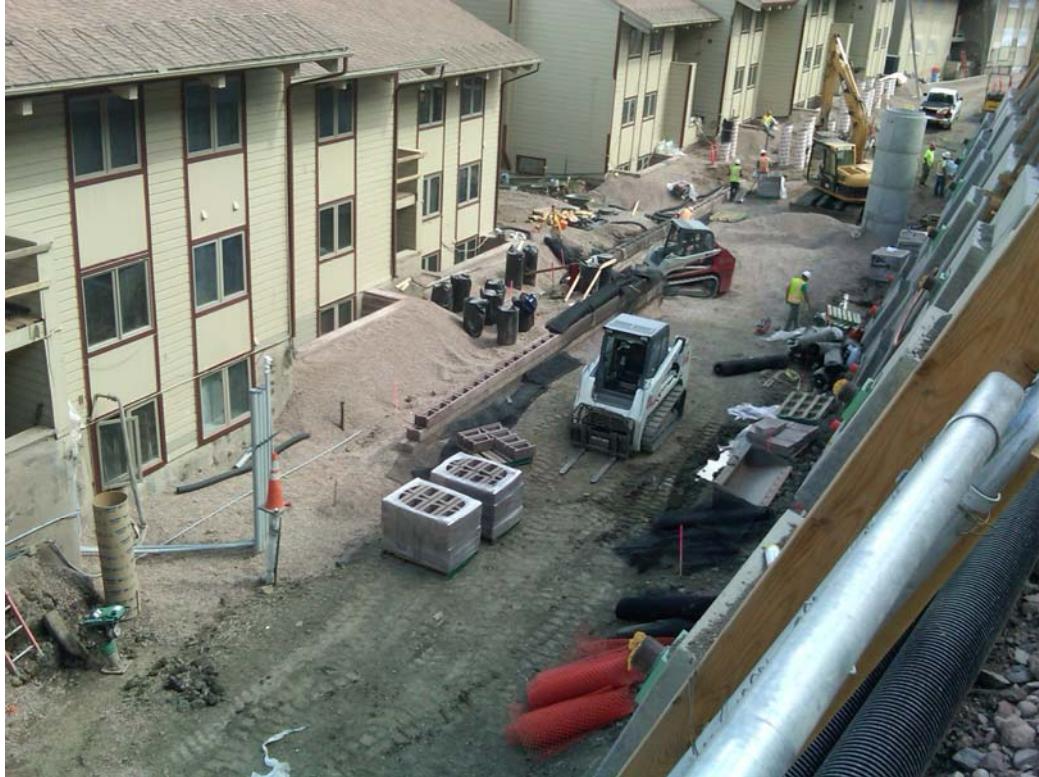
scene

in closer detail. The window wells on the ground floor units in Building I are visible behind the pile of sand/gravel fill; behind that at the center of the photo you can see about three or four layers of the external face of the MSE wall. Two pallets of Allen block – the material that comprises the MSE wall face – have just been off-loaded and are sitting on the site. You may recall the huge cylindrical storm drain featured in an earlier update; you can see it here near the upper right corner of the photo,

standing visible now, but soon to be buried under tons of refill. The depth of this scene can be appreciated by noting that the small round stones on the lower right-hand corner of the photo are, in fact, themselves about five feet below the usual surface of the driveway, and that we are looking down at a construction site more than two stories below this surface. The workmen in the photo look like tiny toy soldiers. Just a few telling reminders of the scope of the excavation that has been done for this project and of the work yet to come of replacing all that was removed earlier this spring and summer.

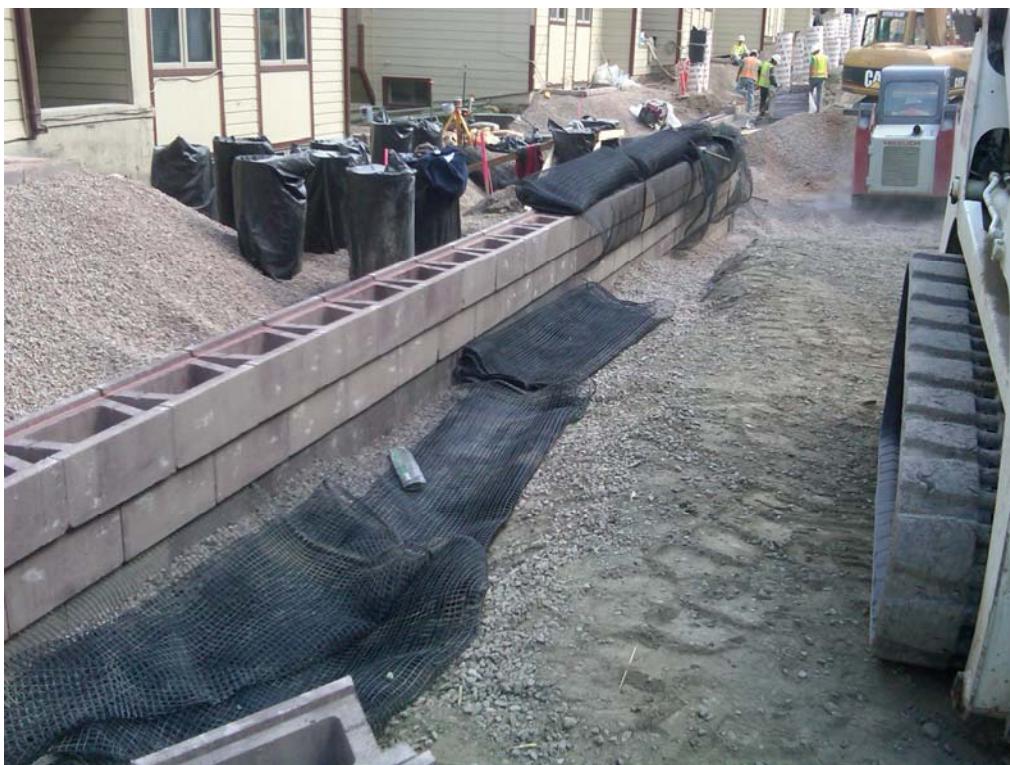
This third picture is a closeup of the backside (the side that will stand against the earthen infill) of the block wall. Hank took this picture while standing behind Building H/I. As with a picture in the last update, you can see the slight backward lean of the wall. This will, of course, be backed with soil in a fill-as-you-go process, so that this side of the blocks will not be visible when the wall is finished.

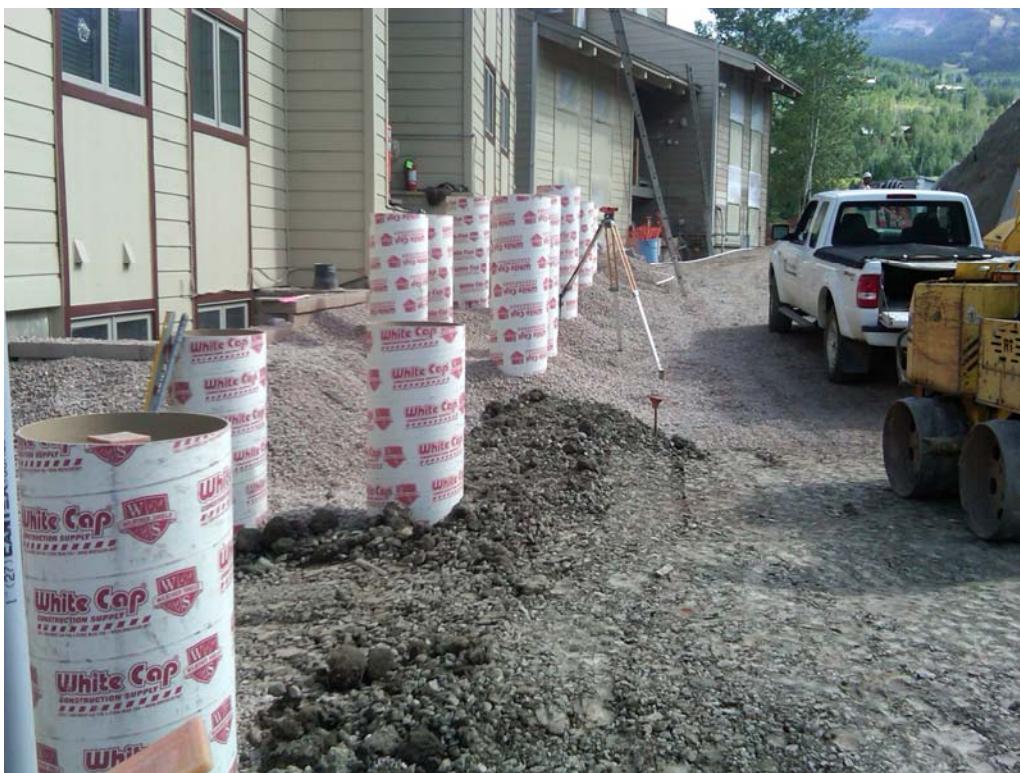
The fourth picture highlights a series of tubular forms for the concrete pylons that will support stairway bridges leading from the driveway to the interior stairwells of the lower buildings; in this picture the building is H-I. Throughout these pictures you can see the new paint palette taking shape as the exterior painting continues to move toward completion.
