## **Snowmass Mountain Construction Update**

### **Week 8: June 5 - 11, 2011 - What Lies Beneath?**

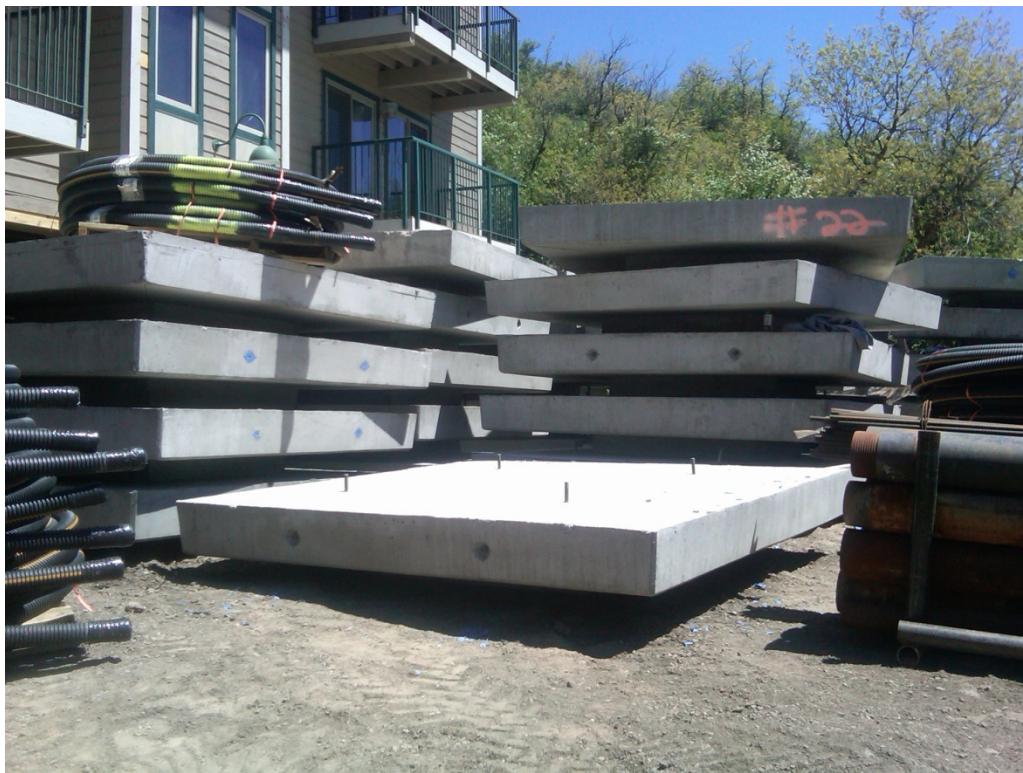
This picture shows the shoring blocks – stacked and ready for installation.

The good news is that the shoring phase has begun. This part of the wall repair will proceed in a series of phases: excavation, insertion of shoring blocks, drilling horizontally into bedrock and then anchoring the shoring block against the earthen mass with a pylon drilled into the bedrock (think of a nut/washer/bolt mechanism), and then moving on to the next shoring block. Almost 50 shoring blocks have been trucked onto our grounds over the past week and truckloads of excavated materials have been moved out. Hank has provided a few pictures of the process which are attached below. The sewer line that is being installed under the roadway is now 70% complete.

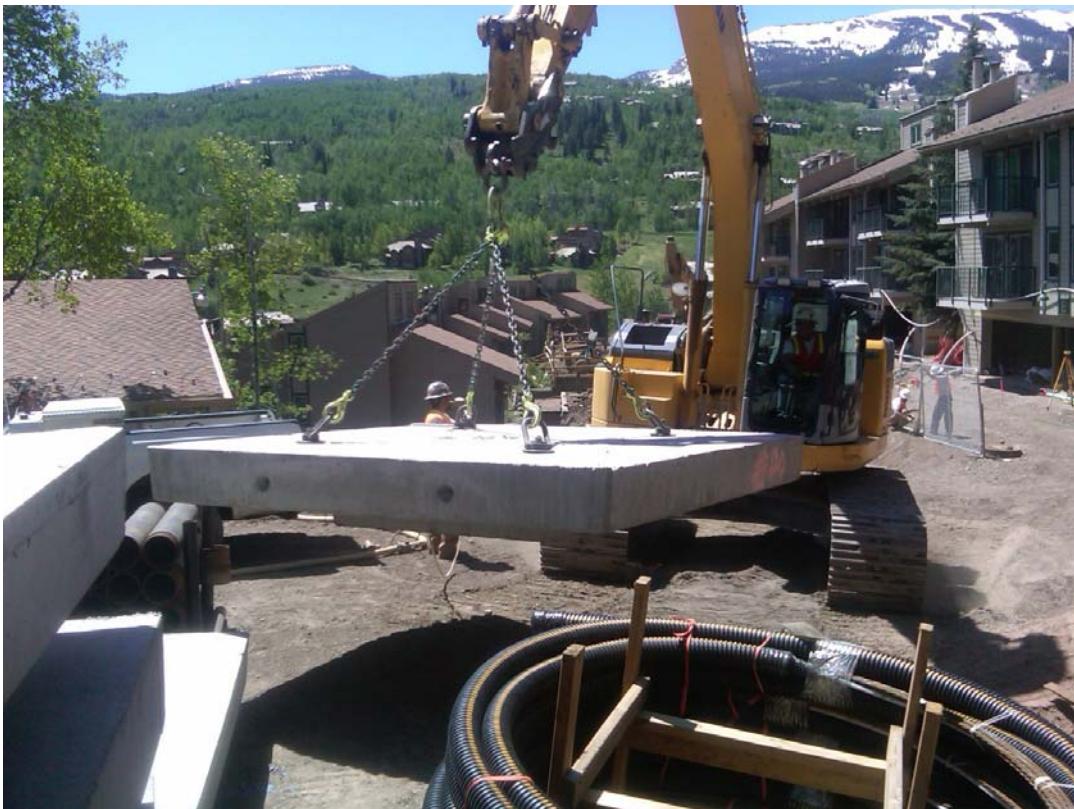
Next is a picture showing how the shoring blocks are moved into position. Note the size of each block.

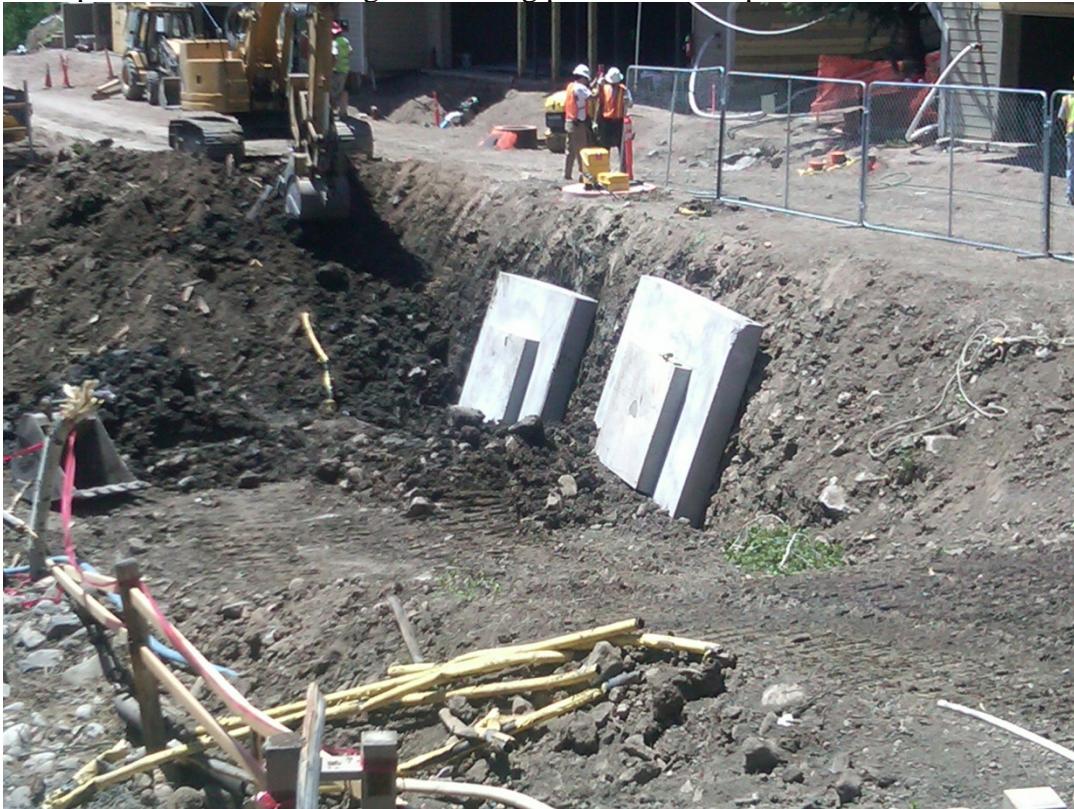
Final picture shows a shoring block being positioned into place.
